**The Club at Cobble Creek
Cobble Creek Owners' Association
Open Space Analysis
Beginning Analysis Date: January 1, 2024**

Executive Summary
Date Prepared - December 26, 2023

This Reserve Management Plan is an assessment of the Common Open Space assets common to The Club and the HOA. This Plan has been requested by The Club Board of Directors to help with the development of a revised Easement Agreement between The Club, the HOA, Spruce Point Development Company LLC, and Montrose Land Partners LLC.

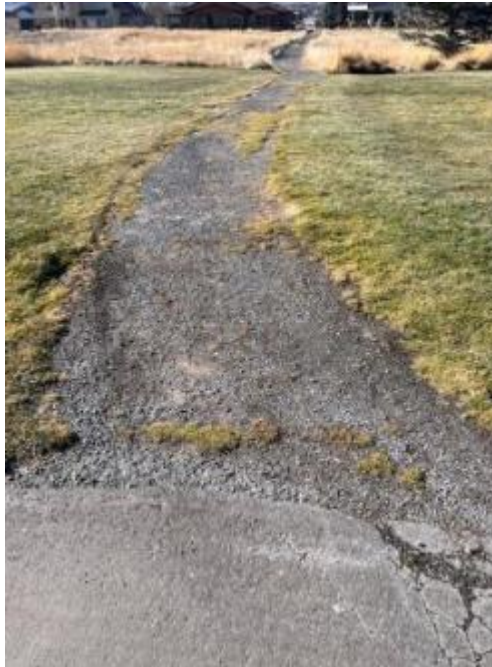
Access Path to Ditch Rider Road

Location: From Grand Mesa Drive to between holes 7 and 8.

Comments: This 425 foot asphalt path was in poor condition at the time of inspection. The current cost to replace this 2,550 square foot path is \$16.60 per square foot which includes removal of the old path and adding a gravel base layer.

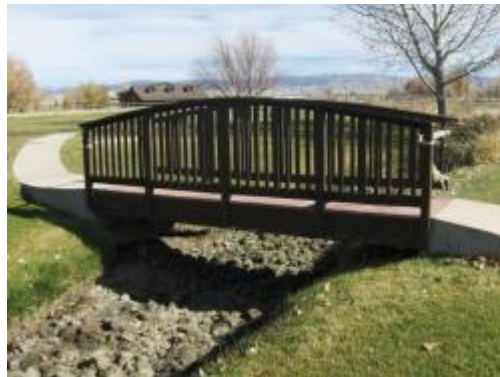
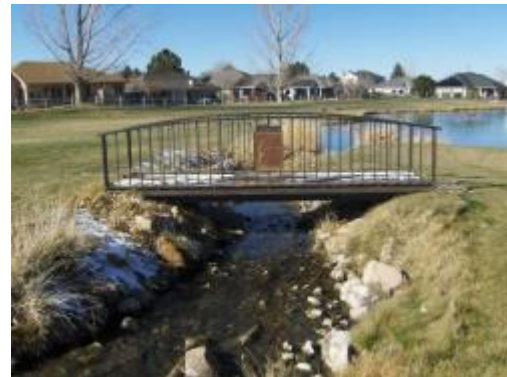
Bridges - Landscape

Location: At the front entrance and the Fish and Chips area. The bridges throughout the golf course are included in the asset component, "Cart Path System".

Comments: The wooden bridge at the front entrance is in poor, unusable condition and needs to be replaced. The Board has stated the bridge will be re-built using many of the existing components. The approximate cost is \$3,000. The estimated useful life after the repairs have been completed is 20 years.

The steel bridge at the Fish and Chips area was replaced in 2016 for \$6,745 and has a useful life of 50 years with a remaining life of 42 years. After adjusting for inflation since 2016, the current estimated cost to replace is \$10,000.

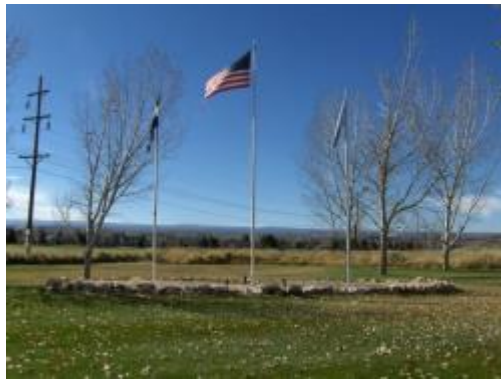
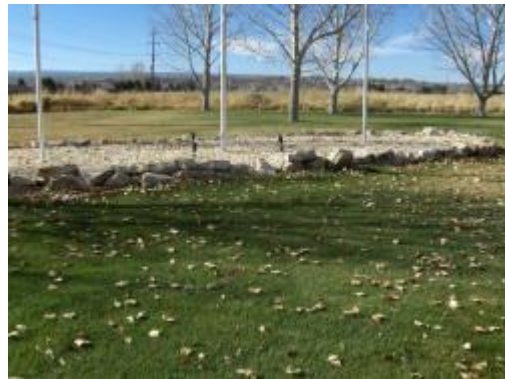
Entrance - Flag Poles

Location: At the Cobble Creek front entrance.

Comments: There are 3 - 20 foot flag poles which were in excellent condition at inspection. The estimated useful life is 35 years with 9 years remaining life. The approximate current cost to replace \$1,250, including labor and removal of the old units.

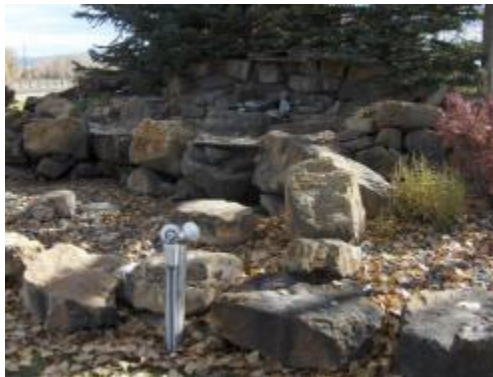
Entrance - Waterfall Pump, Cistern & Pools

Location: At the front entrance.

Comments: According to Paul Heidi, Golf Course Superintendent, "...the collection pools have been compromised. The linings are no longer holding water, and there is substantial leaking which is gradually getting worse. The actual waterfall pump is the original pump, and I believe that it was installed around 2001 or 2002." The cost to correct the lining problem is approximately \$30,000 which includes the fountain pump.

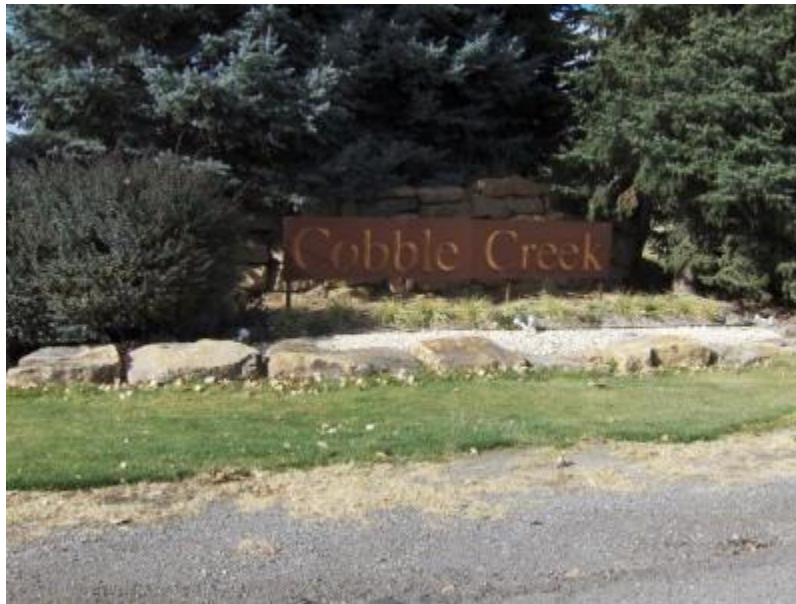
Entrance Sign

Location: Next to the front entrance.

Comments: The sign was in excellent condition at the time of inspection. Based on the current condition, the estimated useful life is 32 years with 6 years remaining life. The current estimated cost to replace is \$3,250 which includes removal of the old sign and installation of the new sign.

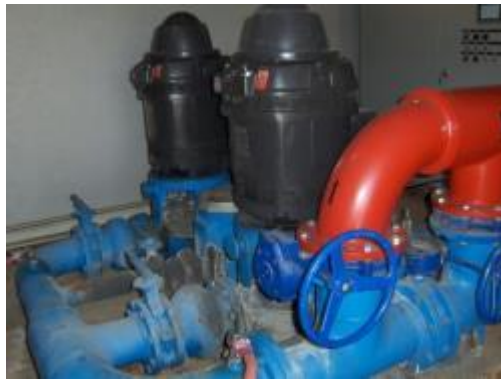
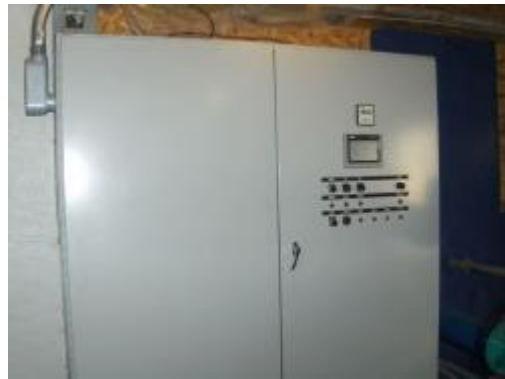
Irrigation Pumps and Equipment

Location: There is one pump house next to the 9th hole fairway and one near the 18th hole tee. There is also a single pump just north of the 11th hole which is owned by the Developer.

Comments: Each pump house has 2 - 50 HP pumps, 1 - 10 HP Jockey pump and an inline filter. One of the large pumps in pump station #2 will be replaced during the winter of 2024 at an actual bid cost of \$64,878. The estimated useful life of this equipment is 22 years. **The Cobble Creek HOA has agreed to pay for this new pump.** Two pumps were replaced in 2021 and another in 2022.

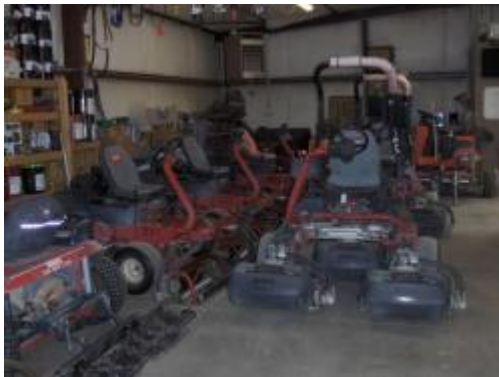
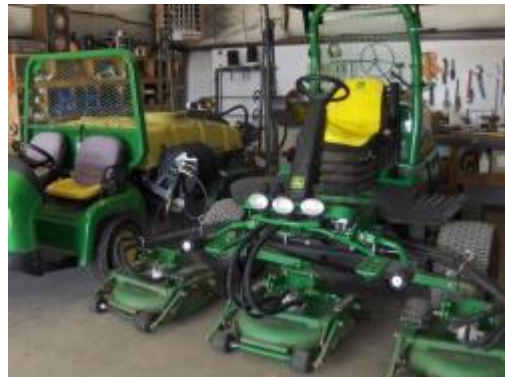
Machinery and Equipment

Location: Stored in the Maintenance Building and used on the golf course.

Comments: In their November, 2022, Projected Capital Expenses and Revenue Options Report, the Long Range Planning Committee (LRPC) stated the following:

"Our golf maintenance vehicles and equipment inventory number 14 with an average age of nine years. We have seven pieces of equipment which are not at or will be over 4,000 hours of operation. Most golf courses replace equipment after 3,000 to 4,000 hours of use. In addition, seven utility vehicles used for golf course maintenance and three Pro Shop service vehicles could be candidates for repair or replacement in the ten-year forecast. Paul Heide has identified one "rough and open-space" mower as a critical priority, recommending its purchase (\$50,000) prior to the start of the 2023 golf season.

The estimated current cost to replace the machinery and equipment on an on-going basis is \$92,500 per year.

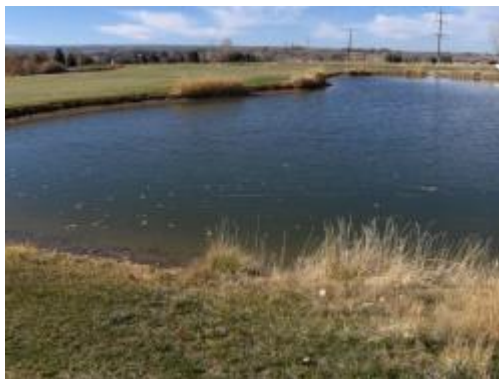
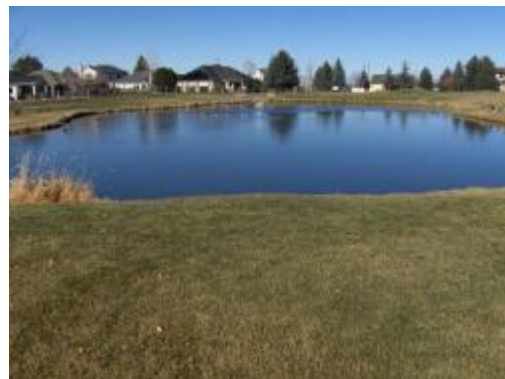
Ponds, Creeks and Retaining Walls

Location: Throughout the golf course.

Comments: In their November, 2022, Projected Capital Expenses and Revenue Options Report, the Long Range Planning Committee stated:

"There are 15 ponds and many thousand feet of creeks connecting those ponds throughout our community. Two priorities have been identified. The stone wall next to the 16th green has begun to fail and needs immediate attention. Several options were explored and, in consultation with course superintendent, Paul Heidi, the recommendation is to proceed with a gabion retaining wall at a cost of \$28,830. Due to the existing deteriorated condition, this is a high priority. Funding needs to be identified for construction to occur in November, 2023, when the pond can be drained.

The second priority is the stone wall and adjacent cart path on hole #1. Options are still being discussed regarding this priority.

Additionally, the remaining ponds and creek banks should be monitored for erosion. A \$35,000 annual budget is included in the LRPC forecast for all of these needs."

In 2024 an additional expenditure for the hole 16 gabion wall has also been included of \$28,830, adjusted to \$30,100 due to inflation.

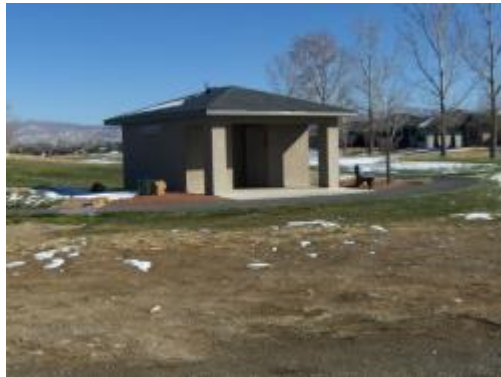
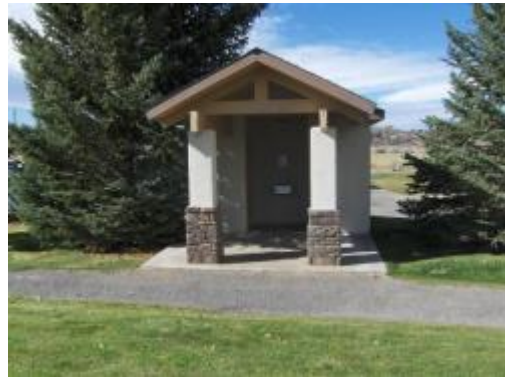
Restrooms - Golf Course

Location: 1 restroom between holes 5 and 6, 1 at hole 12, and 1 at holes 15 - 16.

Comments: According to the Golf Course Superintendent, Paul Heidi, the restroom at hole 12 was constructed in the early 2000's, the restroom at holes 15 - 16 in 2006 - 2007 and the restroom building between holes 5 & 6 in 2017.

The historical improvements to the restroom facilities are unknown. Therefore, it is recommended the stucco be painted in 2028 when the buildings in the Clubhouse area are done. The asphalt shingle roofs can be replaced in 2030 and 2039 when the roofs on the buildings in the Clubhouse area are done. It is recommended the interior of the restrooms be renovated in 2037, 2042, and 2052 at a projected cost of \$12,000 per restroom.
